Material and failure analysis

Aerospace Vehicles Division
Structures Testing & Evaluation

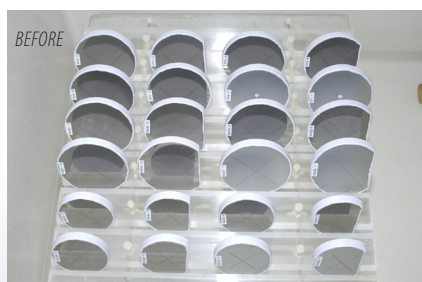
Salt spray test for the replacement of chroming plating as applied on landing gears (left side before the test, right side after 192 test hours)

The replacement and/or implementation of new materials or coatings are driven by technical performance, costs or environmental requirements. For aerospace applications, these new materials or coatings must be validated on the effectiveness to the service live. NLR is fully equipped to guide you through the entire validation process. An example of this validation is the replacement of chroming plating on landing gears of airplanes.
